Status of JAEA-ISOL

Akihiko OSA Tandem Accelerator section, JAEA

21/03/2013

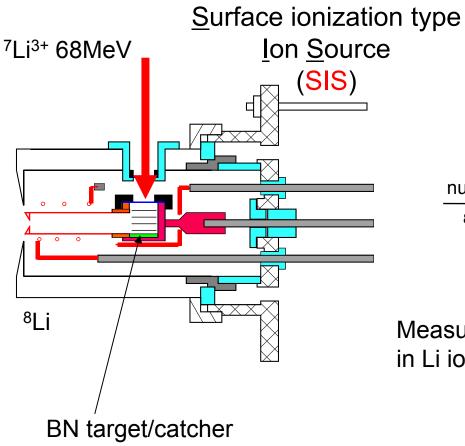
Ion sources for JAEA-ISOL

nuclide	Intensity (pps/300pnA)	Primary beam	target
⁸ Li	1 x 10 ⁷	⁷ Li	BN

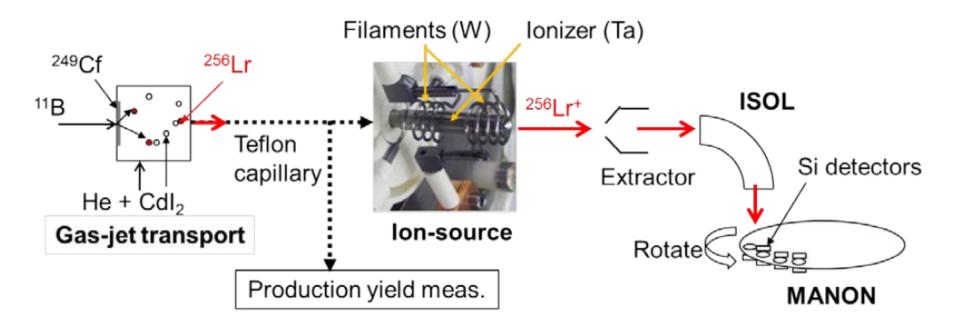
Gas-jet coupled Surface Ionization Ion source

Measurement of the first ionization potential of Lawrencium and decay spectroscopy of actinides

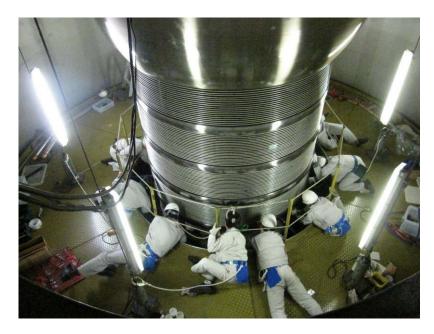
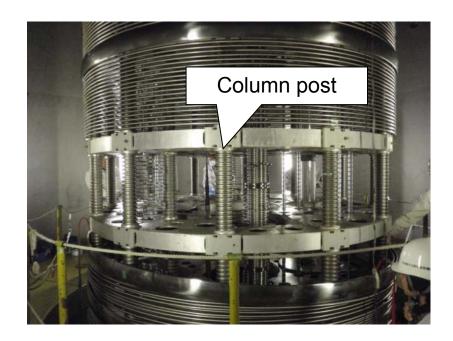
Exchanging work

Cracked column post :33 of 240 (broken post:4)

27 posts were exchanged; brand-new/spare: 20, recycle after shearing test: 7.
